Manhole Inspection Summary

Manhole # S13KK1032MH

Location Address: **4601 PALL MALL RD**

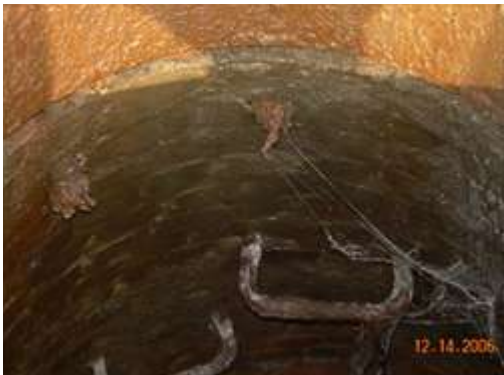
Defect

☒ **Leaks**

Condition: ☐ Sound ☐ Cracked ☐ Root Intrusion ☐ Loose Brick ☒ **Deteriorated**

Infiltration: ☐ None ☒ **Joint** ☐ Cracks ☒ **Mortar** ☐ Roots ☐ Wall

☒ **Corroded**

Frame leaks. Adjustment deterioration and infiltration. Corroded and missing steps.

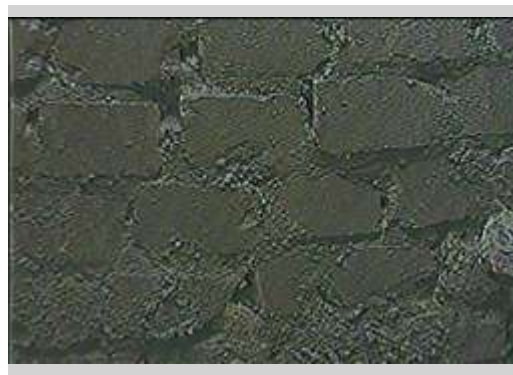
Defect

Infiltration: ☐ None ☐ Joint ☐ Cracks ☒ **Mortar** ☐ Roots ☒ **Wall**

Barrel infiltration.

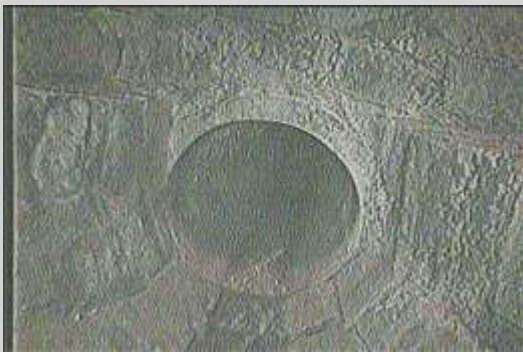
8 in. Circular Gravity Sewer Pipe Out @ 12 O'Clock

Infiltration: **None** Pipe Seal Cond: **Cracked**

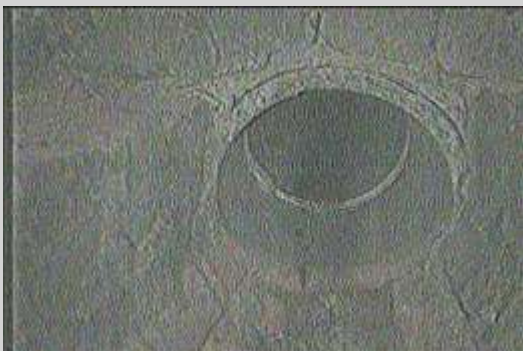
8 in. Circular Gravity Sewer Pipe In @ 4 O'Clock

Infiltration: **Evidence** Pipe Seal Cond: **Unknown**

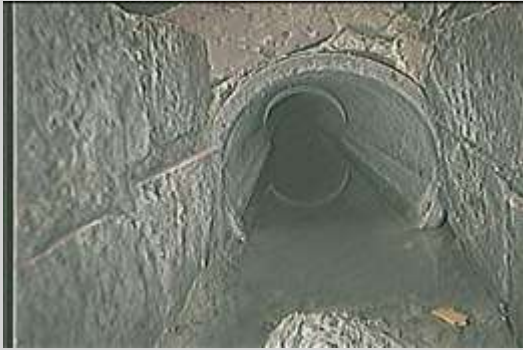
8 in. Circular Gravity Sewer

Infiltration: **None** Pipe Seal Cond: **Cracked**

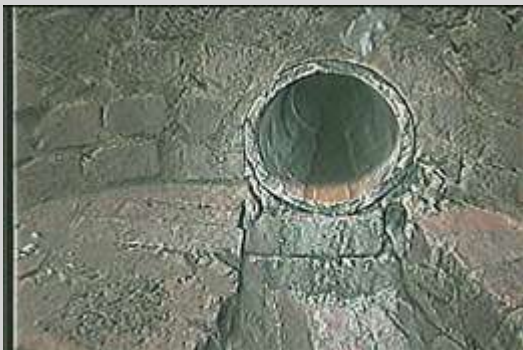
8 in. Circular Gravity Sewer

Comments **The I8 pipe picture shows Channel deterioration.**

Condition: ☐ Sound ☐ Cracked ☐ Root Intrusion ☒ **Deteriorated** ☐ Leaks ☐ Debris

Channel deterioration.

Deposits: ☐ None ☐ Mud ☐ Sludge ☐ Debris ☒ Grease

Infiltration: **Evidence** Pipe Seal Cond: **Unknown**
